# Development of a flowchart method for source detection of illicit discharges into stormwater drainage systems in Cape Town

Stormwater drainage systems discharging non-storm water add substantial pollution to urban watercourses, with negative impacts to water quality and aquatic ecosystems. Thus, the elimination of these discharges can be a highly effective non-structural best management practice (BMP) to improve water quality. This study aimed to guide local municipalities whose task it is to control polluted non-storm water entries into the stormwater drainage system. The study evaluated procedures, methodologies and techniques of illegal discharge detection and elimination (IDDE) programme components, as practised internationally, and applied these in a local condition to verify their feasibility and challenges. The paper provides guidance to identify and prioritise investigations for controlling illegal discharges into stormwater drainage systems. Challenges encountered in the study included lack of legal authority to undertake inspection, surveillance and monitoring at private and corporate properties, and to undertake requisite enforcement measures to remove sources of ille

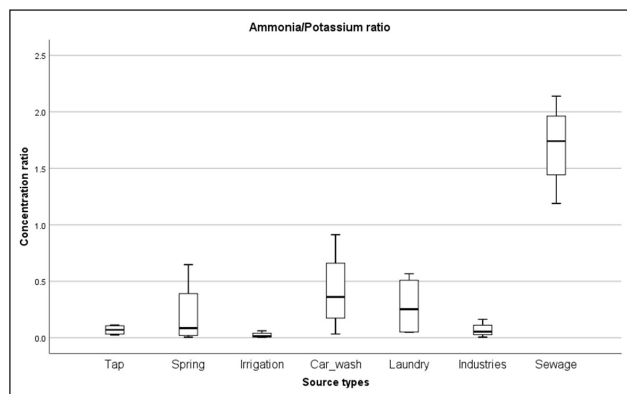
Figure 2. Ammonia/potassium ratio comparison for different source types

Data from the ‘fingerprint library’ were used to create box-and-whisker plots to establish a concentration pattern for each indicator parameter. For example, Fig. 2 shows the box-and-whisker plots for the ammonia/potassium ratio parameter. The box for sewage does not overlap with any of the other flow-type box plots. The inference here is that the ammonia/potassium ratio for sewage is significantly different and could be used to distinguish sewage flows from wash-waters and all other flow types, at least at the 95% confidence level. Library data from the flow types (tap, spring, irrigation, car wash, laundry, industries and sewage) were analysed to define a suitable threshold value for each parameter to use as an indicator of illegal discharge. The library tabular data and box plots were studied in detail to select concentration values as ‘indicators’ of illegal discharges. The process of defining the threshold values is described extensively in Brown et al. (2004 p. J3–5). Examination of the box plots indicated that uncontaminated waters (tap and spring waters) could be distinguished from the contaminated waters (irrigation, car wash, laundry and sewage) by the following indicator parameters: detergents (anionic surfactants), fluorescence (optical brighteners), potassium, total chlorine, total hardness and turbidity. These inferences were made because the uncontaminated flow types’ box plots for these parameters do not overlap with the contaminated box plots. Of these parameters, detergents and fluorescence are of much interest as they result from the use (anthropogenic) of water and are in various ways present in wastewater (sewage) and wash waters. Box plots for detergents, fluorescence, ammonia and conductivity are shown in Figs 3, 4, 5 and 6, respectively.

greater than 1. This observation has been noted by Pitt and Rittenhouse (2001) in several studies in the US, but they could not establish such an observation for wash waters and neither could this study. It was, therefore, logical to give preference to ammonia/potassium ratio as a parameter to distinguish between sewage and wash waters.

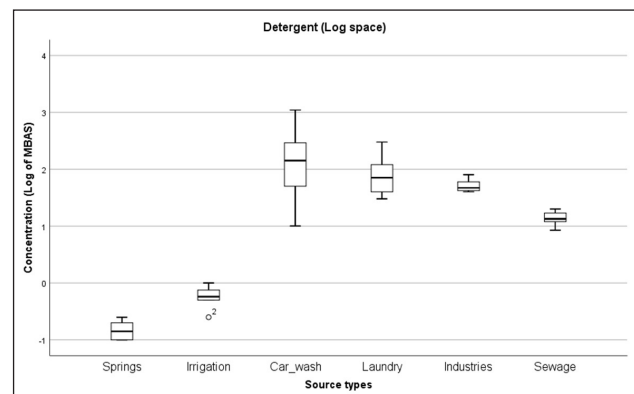
Figure 3. Detergent (anionic surfactants) comparison for different source types in log space

Further, among the contaminated waters, the box plots revealed that irrigation waters could be distinguished from sewage and wash-waters by ammonia and detergent (Figs 3 and 5). Wash-waters could be distinguished from sewage by ammonia, ammonia/potassium ratio and detergents. Analysis of 1-year records of raw sewage data from the CoCT, showed that ammonia/potassium ratio was always

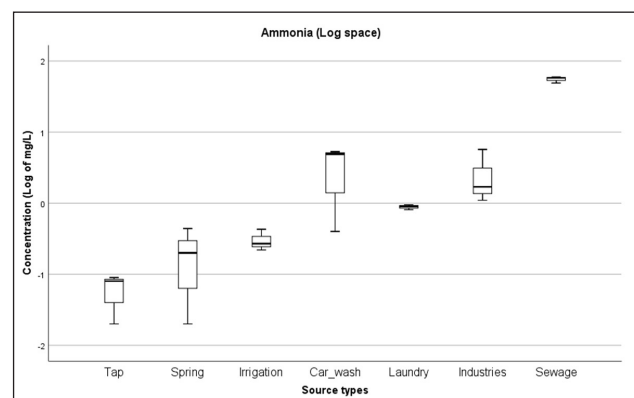
Figure 5. Ammonia comparison for different source types in log space

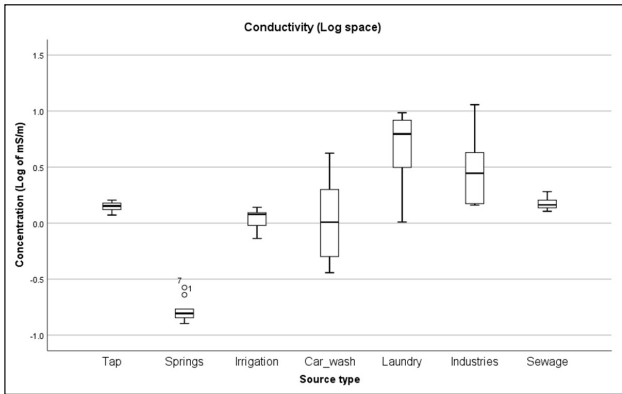
**Figure 6.** Conductivity comparison for different source types in log space

Between the uncontaminated waters, the box plots revealed that tap water may be distinguished from spring water by the following parameters: conductivity (Fig. 6), detergents, and fluorescence. In uncontaminated waters, however, detergents and fluorescence (caused by optical brighteners) are least expected. Preference was thus given to conductivity as a parameter to distinguish between local tap and spring waters.

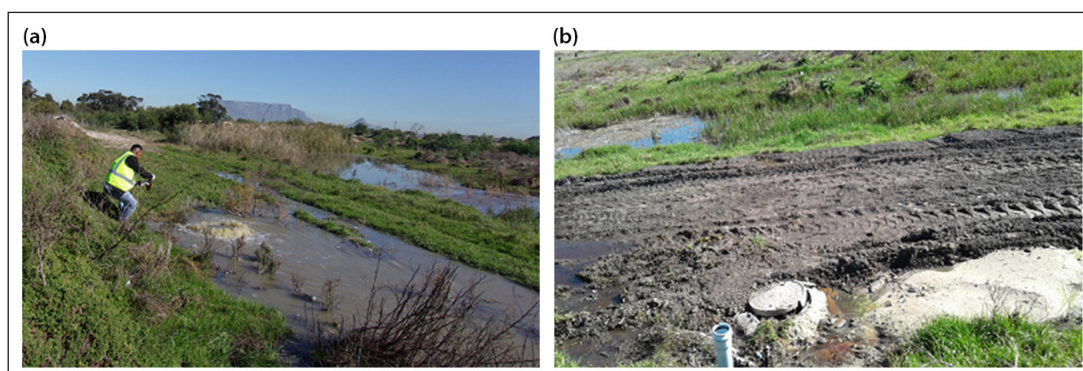
**Figure 11.** Photo of chronic sewer overflow near Milnerton Riding Club: (a) pond created by chronic sewer overflow; (b) sewer overflow repaired

A surface flow was observed near Outfall D12; however, a review of the stormwater drainage map could not reveal any stormwater pipe or channel discharging to the proximity of the surface ponding. A drainage area investigation was initiated to find the source of the discharge to be a chronic sewer overflow (Fig. 11a), which has created a pond upstream of the outfall location. The location of the overflow is on the sewer mains from Dunoon industrial area to Potsdam Wastewater Treatment Works. The incident was reported to the City and the site was restored (Fig. 11b).

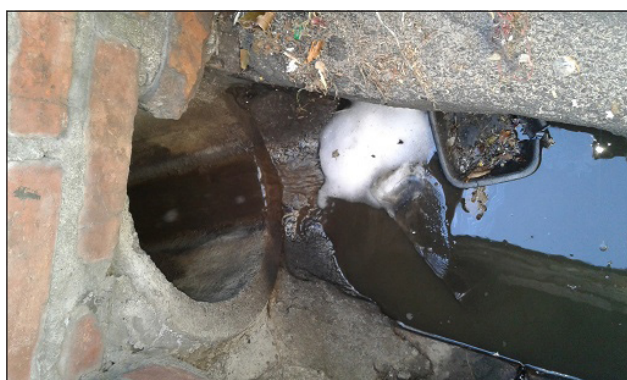
Figure 12. Carwash effluent discharging into Manhole 19MON

Montague Gardens industrial area discharges through Montague channel to Outfall D20 (not shown on map). Due to the vastness of this area, the drainage network was split into segments and storm drain investigation was conducted for selected segments and manholes. Concentrations of detergent (10.23 mg/L as MBAS) and fluorescence (79.76 RFU) at Outfall D20 exceeded the action criteria and since the ammonia-potassium ratio was very small (0.03 and less than action criteria), the source type was inferred to be wash-waters and the field crew task was to look for their sources. Discussion of some of the results from the investigation are summarised as follows:

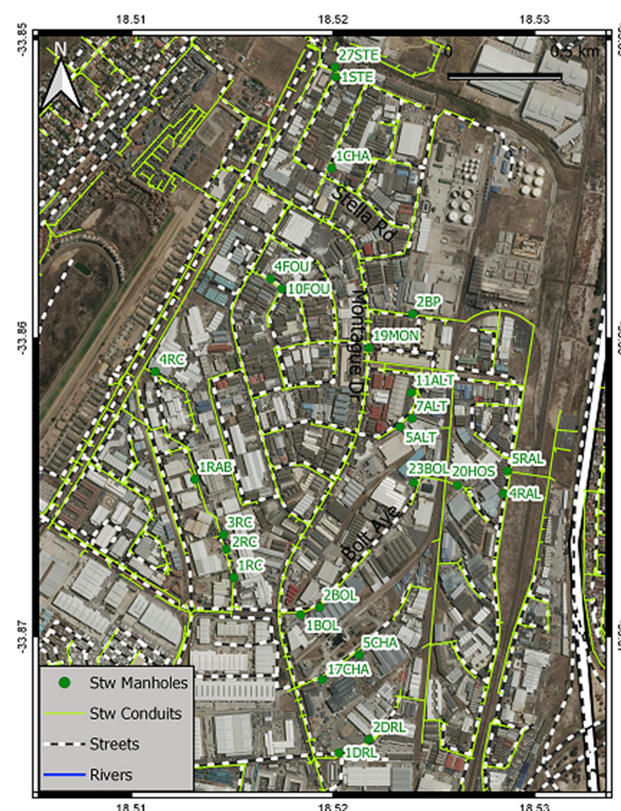
Figure 13. Montague Gardens sub-catchments map

Locations of Manholes 1STE and 27STE are shown in Fig. 13. Manhole 1STE is at a junction between Stella Road and Stella Cove and the discharge observed in this manhole had a brownish-grey colouration (Fig. 14a). Inlet 27STE is in front of Unit 27 (chemical factory) on Stella Cove and a whitish discharge (Fig. 14b) was observed in the drain flowing from the factory premise. Concentrations of detergent for Manholes 1STE and 27STE are 35 and 109 mg/L as MBAS, respectively. Concentrations of fluorescence for 1STE and 27STE manholes are 168.6 and 104.4, respectively. These concentrations exceeded the established local action criteria and with low ammonia concentrations at each location, a wash-water source type was confirmed. The City is advised to conduct a site investigation to identify the culprit(s) of discharge in 1STE manhole.

Locations of Manholes 4FOU and 10FOU are shown in Fig. 13. Manhole 4FOU is located on 4 Fourth Street in Montague. The discharge rate was substantial and had a deep maroon colour (Fig. 15). Concentrations of detergent and fluorescence were 31.5 mg/L as MBAS and 164.32 RFU, respectively, both exceeding local action criteria limit. The source type is inferred as factory wash-water. The next upstream manhole (10FOU) had a small and clear discharge. The potential culprit may be discharging into the pipe segment between these two manholes.

These manholes are located on Rainbow Close in Montague industrial area (Fig. 13). Manhole 1RC is at the upstream part of the segment followed by 2RC, 3RC and 1Rainbow towards the downstream section. Concentrations of detergent and fluorescence (Table 5) exceed local action criteria, whereas ammonia-potassium ratios are all lower than action criteria for sanitary wastewater. Wash-water source type is inferred, and an effort must be made by the City to identify the industries responsible for the discharges.

These manholes are located on Drill Avenue in Montague industrial area (Fig. 13). Manhole 1DRL is downstream of 2DRL. During the inspection, there was a trickling flow in 1DRL whereas a white milky discharge was observed in 2DRL. Detergent and fluorescence concentrations in 2DRL are 3.49 mg/L as MBAS and 140 RFU, respectively; all exceeding the local action criteria. Further site investigation to identify the industry discharging wash-water into 2DRL manhole is recommended.

These manholes are located on Chain Avenue in Montague industrial area (Fig. 13). Manhole 17CHA is downstream of 1CHA whilst 5CHA is on the upstream part of the segment. Detergent and ammonia-potassium ratio in all three manholes are low but fluorescence concentration exceeds the local action criteria. The concern with discharge in 17CHA manhole (Fig. 16) is high conductivity (7.096 mS/m) and COD concentration (470 mg/L). Wash water may not be the source type, but high conductivity and COD concentrations suggest industrial discharge and must be further investigated.

These manholes are located on Alternator Avenue in Montague industrial area (Fig. 13). Manhole 5ALT is upstream followed by manholes 7ALT and 11ALT further downstream. Manhole 5ALT was blocked and filled up with stones and litter (Fig. 17a). Discharge rates of about 2.5 and 10 L/s were measured in 7ALT and 11ALT, respectively. The colour of the discharge in 11ALT was pinkish (Fig. 17b), whereas 7ALT, which was about 40 m away, upstream, had clear water flowing. A white soapy foam was observed in manhole 7ALT (Fig. 17c) and with concentrations of detergent and fluorescence exceeding local action criteria (Table 4), it was not difficult to confirm that the source type in Manhole 7ALT is wash-water. A stormwater inlet in front of Alternator Park complex connected to Manhole 7ALT indicated stains of paint (Fig. 17d) which suggest dumping has been taking place into the stormwater drainage system. The COD measured in both manholes was more than 2 000 mg/L, also confirming that the discharges are of industrial origin. The discharge source type is inferred in Table 5.

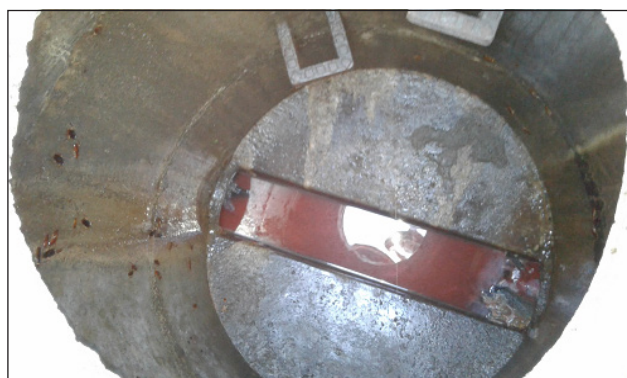
**Figure 15.** Photo of deep maroon colour discharge in Manhole 4FOU

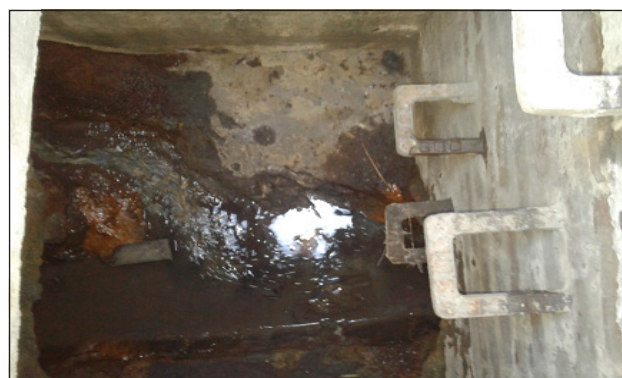
**Figure 16.** Photo of an illegal discharge in Manhole 17CHA

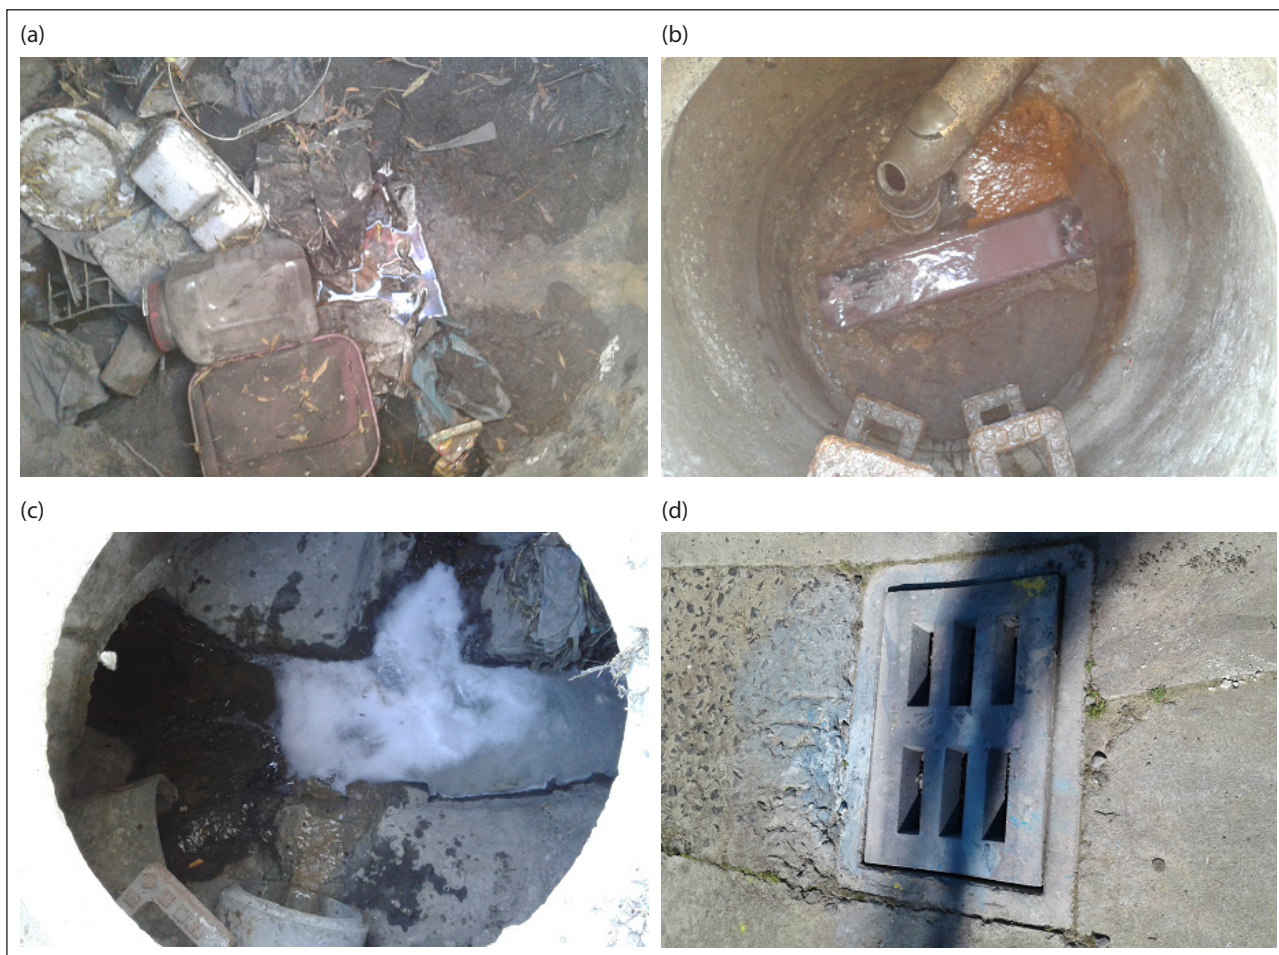
**Figure 17.** Photos of illegal discharges in manholes on Alternator Avenue: (a) Manhole 5ALT filled with stones; (b) Manhole 11ALT with pinkish discharge; (c) Manhole 7ALT with white soapy foam discharge; (d) stormwater inlet with stain

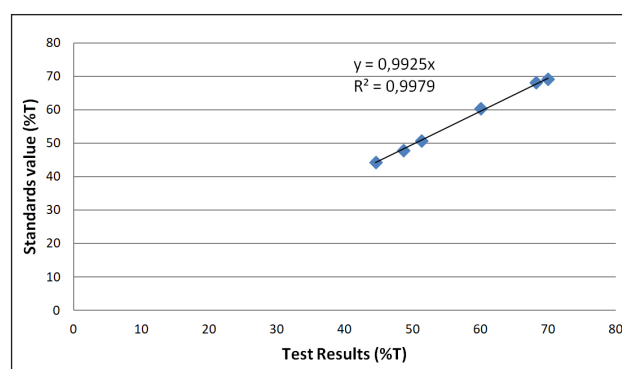
**Figure 18.** Palintest Photometer 7500 compliance with certified standards

A calibration certificate supplied with Palintest Photometer 7500 Bluetooth validates the performance of the instrument. 'Palintest Check Standards set is supplied with certified values expressed as %T (Transmission), derived from traceable reference materials. Acceptable tolerances defined on the certificate are automatically specified within the Photometer 7500 Bluetooth', (www.palintest.com). Routine validation was conducted to check standard values and measurements to ensure the instrument was operating within the defined specification and that the results were credible. Results of check standard values and measurements (Fig. 18) indicate that the Palintest photometer was capable of producing reliable results.
